PANTEX ENVIRONMENTAL RESTORATION

High Explosives Detection Monitoring in the Ogallala Aquifer

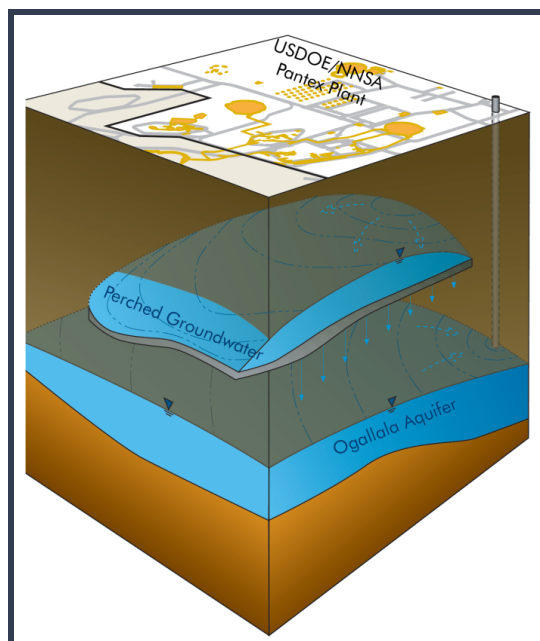
Groundwater Beneath Pantex

The Pantex Groundwater Resource Conservation and Recovery Act Facility Investigation Report identified impacts to perched groundwater that require corrective action. The Pantex Site Wide Human Health Risk Assessment found that perched groundwater underneath the Pantex Plant contains high explosives and other constituents that could migrate over time to the Ogallala Aquifer, the main drinking water source for the area. The area of primary concern is in the southeast corner of the main Plant and offsite, adjacent to this area. The fine-grained zone prevents vertical migration in most areas, but becomes thinner and more permeable in the southeast where migration to the Ogallala Aquifer is possible.

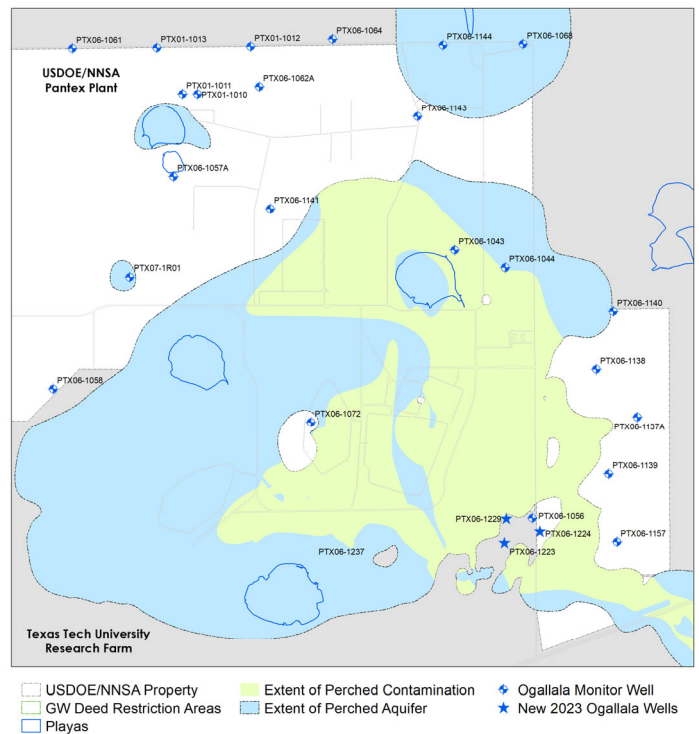
Ogallala Monitoring Well Network

Three new Ogallala monitoring wells (PTX06-1223, PTX06-1224, and PTX06-1229) were installed in 2023 (blue stars on map). The new wells were installed in areas identified in earlier plume modeling for being at risk of vertical contaminant migration from the perched to the Ogallala Aquifer. Initial results from PTX06-1223 indicate DNT4A and RDX at similar concentrations to recent samples from PTX06-1056, though all concentrations were below the ground-water protection standards (GWPS).

Pantex requested special funding to implement measures to begin evaluating extent of the detections by installing three additional Ogallala monitor wells in 2024 (orange stars on map). Fate and transport modeling is being utilized in 2024 to plan future drilling locations and to evaluate potential sources for the detections at PTX06-1229. Further installations will be evaluated after gaining information from the new 2024 wells and fate and transport modeling. Pantex is
