Environmental Projects: Public Meeting

November 9, 2023

Remedial Action Status at Pantex

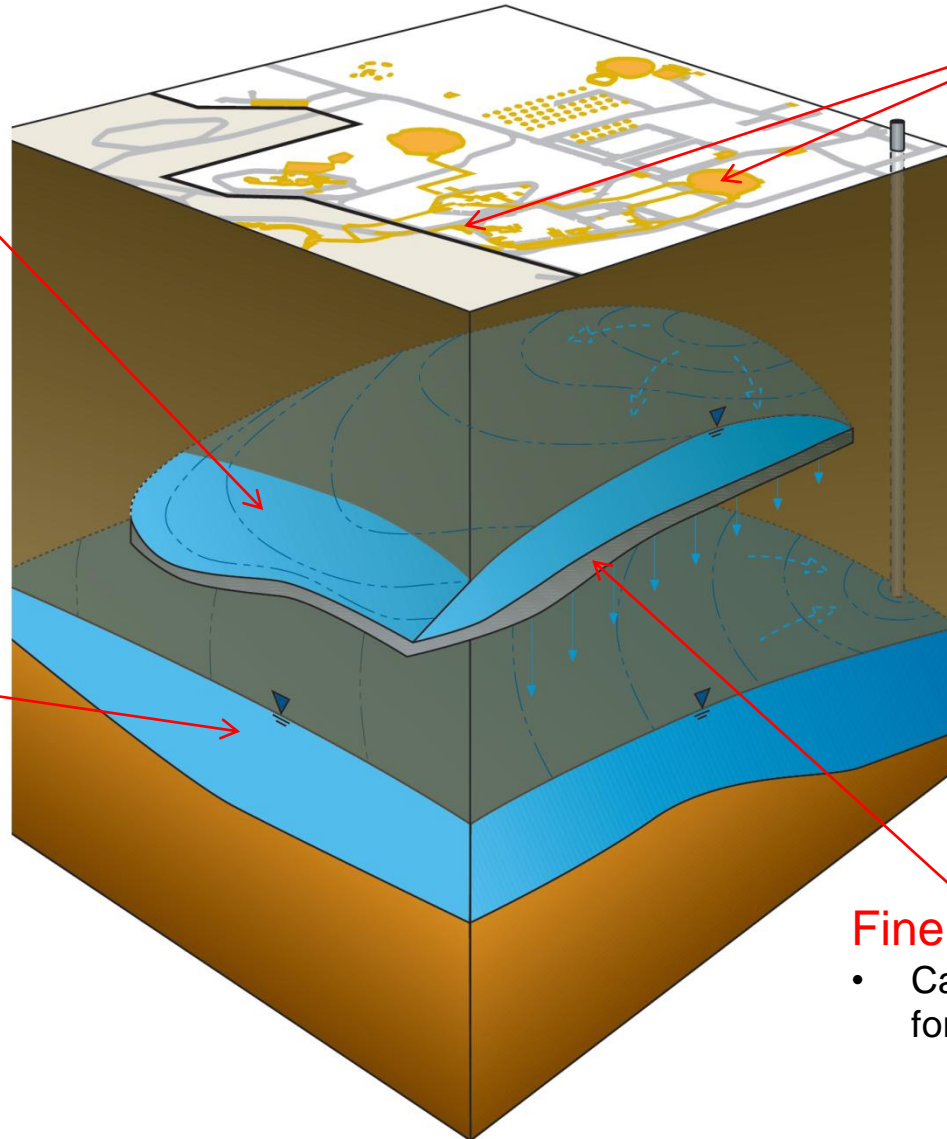
Groundwater Flow at Pantex

Perched Aquifer

- Depth: 200-300 ft bgs
- Saturated thickness: <1 to 75 ft (avg 15 -20')

Ogallala Aquifer

- Regional drinking water resource
- Depth: 400-500 ft bgs
- Saturated thickness ranges from 100-400 ft occurs 100-200 ft beneath perched aquifer

Playas/Ditches

- Past discharges of legacy wastes expanded our perched aquifer and contributed high explosives, solvents, perchlorate and chromium to perched groundwater

Fine Grained Zone (FGZ)

- Causes perched water to form

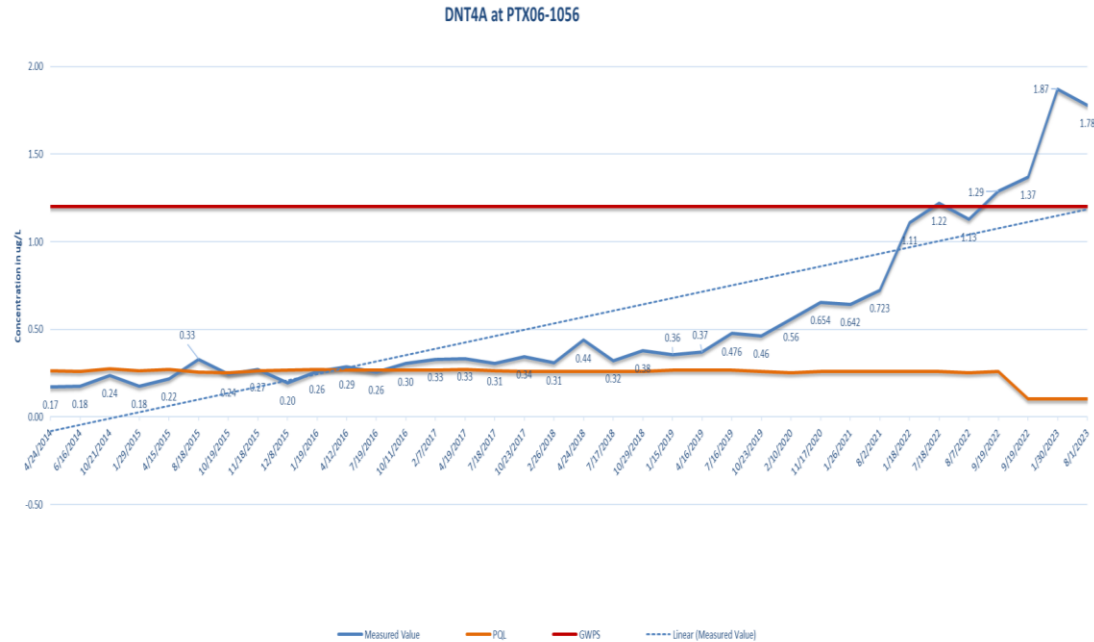
Ogallala Detections

PTX06- 1056 (DNT4A)

- First detected in April 2014 at 0.17 ppb, below the practical quantitation limit (PQL) of 0.262 ppb
- Slow increasing trend throughout the years
- First detect above cleanup value (GWPS – groundwater protection standard) was in July 2022

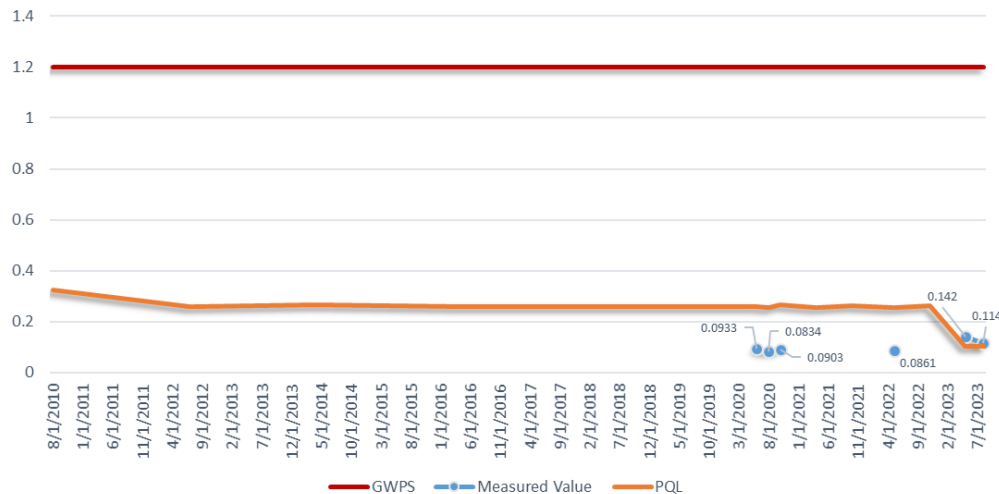
PTX06-1076 DNT4A Detections

PTX06-1076 - (DNT4A)

- First detected in June 2020 at 0.09 ppb, below the practical quantitation limit (PQL) of 0.26 ppb
- Sporadic detections since that time
- First detect above PQL (practical quantitation limit) was in May 2023
- Detection limit improvement when we moved analysis to a new lab
